Presentation preliminary results criminal investigation MH17 28-09-2016

Today, the Joint Investigation Team (JIT) presents the first results of the criminal investigation into the downing of flight MH17 on 17 July 2014.

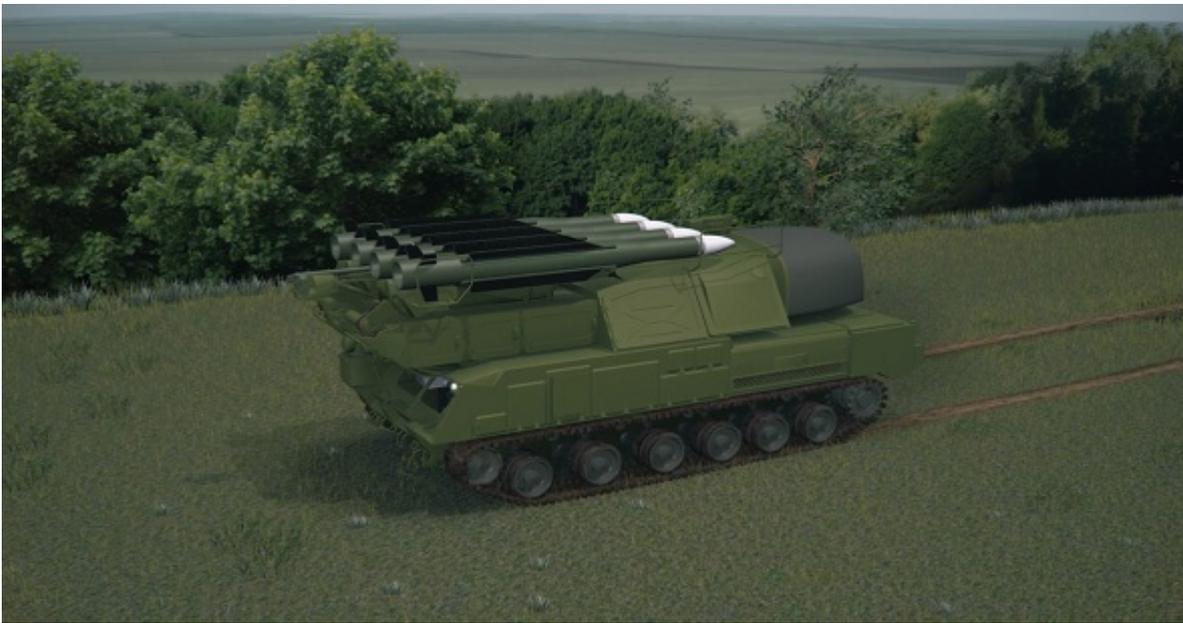
Image: BUK-TELAR

Based on the results of the criminal investigation it can be concluded that flight MH17 was shot down on 17 July 2014 by a missile of the 9M38 series, launched by a BUK-TELAR. This is consistent with the conclusions drawn by the OVV of 13 October 2015. The BUK-TELAR was brought in from the territory of the Russian Federation and subsequently also taken back to the Russian Federation.

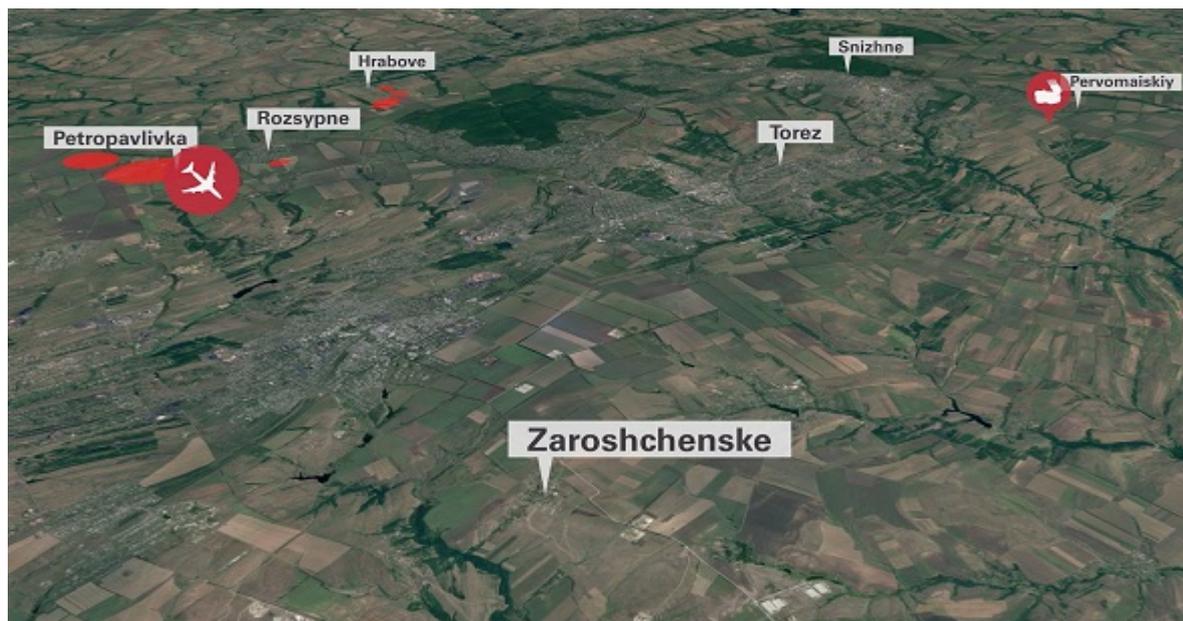
Image: map of Ukraine with Zaroschenke

The JIT investigated several possible launch locations, including two locations in the vicinity of the town of Zaroschenke or Zaroshchenskoye. Among other locations, this area was indicated by the Russian Ministry of Defence as being the launch site. It was also mentioned that this area was allegedly controlled by Ukraine. However, the investigation showed that this was not the launch location. And besides this, it appeared that this area was not being controlled by Ukraine, but by pro-Russian fighters. To illustrate this there is the following intercepted telephone conversation between two pro-Russian fighters:

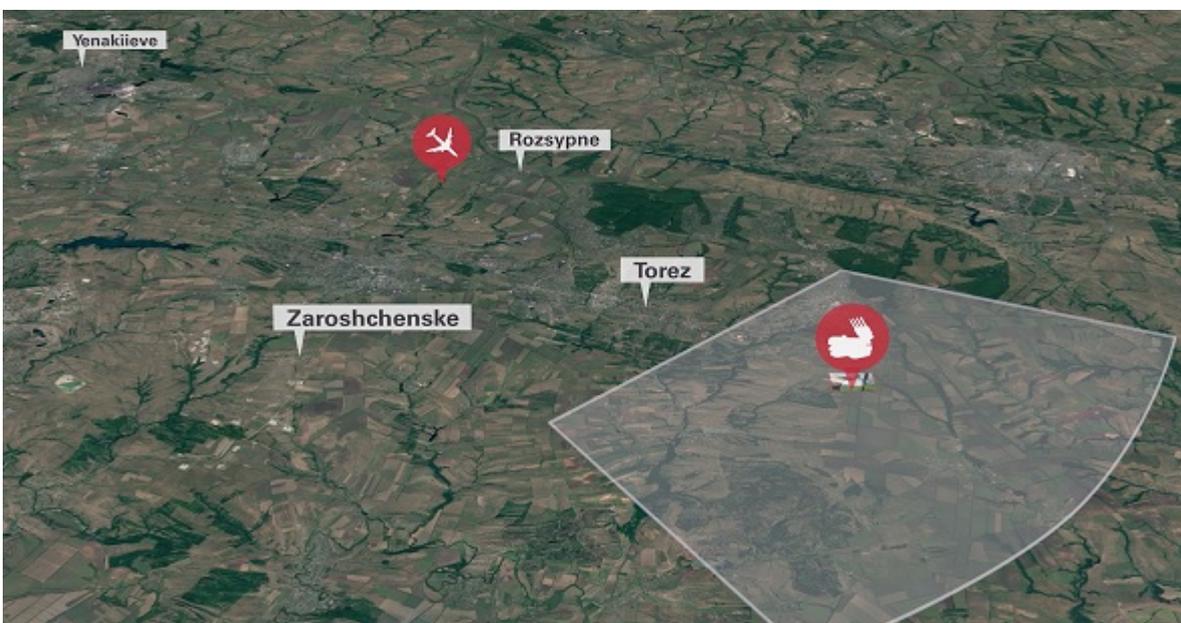
Image: Launch site

During the past two years, the investigation team collected a large quantity of evidentiary material about the launch site. Our conclusion is that the location of the launch site is an agricultural field near Pervomaiskiy. It concerns a field of approximately 500 x 600 metres. This is the highest spot in the area within a radius of 5 kilometres. The farmland is surrounded by trees, except for the western side. Previously the OVV had already concluded that the missile must have been launched from an area of 320 square kilometres south east of Grabovo. The farmland near Pervomaiskiy is located in this area.
